# COMMANDER FLEET ACTIVITIES SASEBO FLEET MOORINGS UNDERWATER INSPECTION REPORT

SEPTEMBER 1983

OCEAN ENGINEERING  
AND CONSTRUCTION PROJECT OFFICE  
CHESAPEAKE DIVISION  
NAVAL FACILITIES ENGINEERING COMMAND  
WASHINGTON, D.C. 20374

FPO-1-83(28)

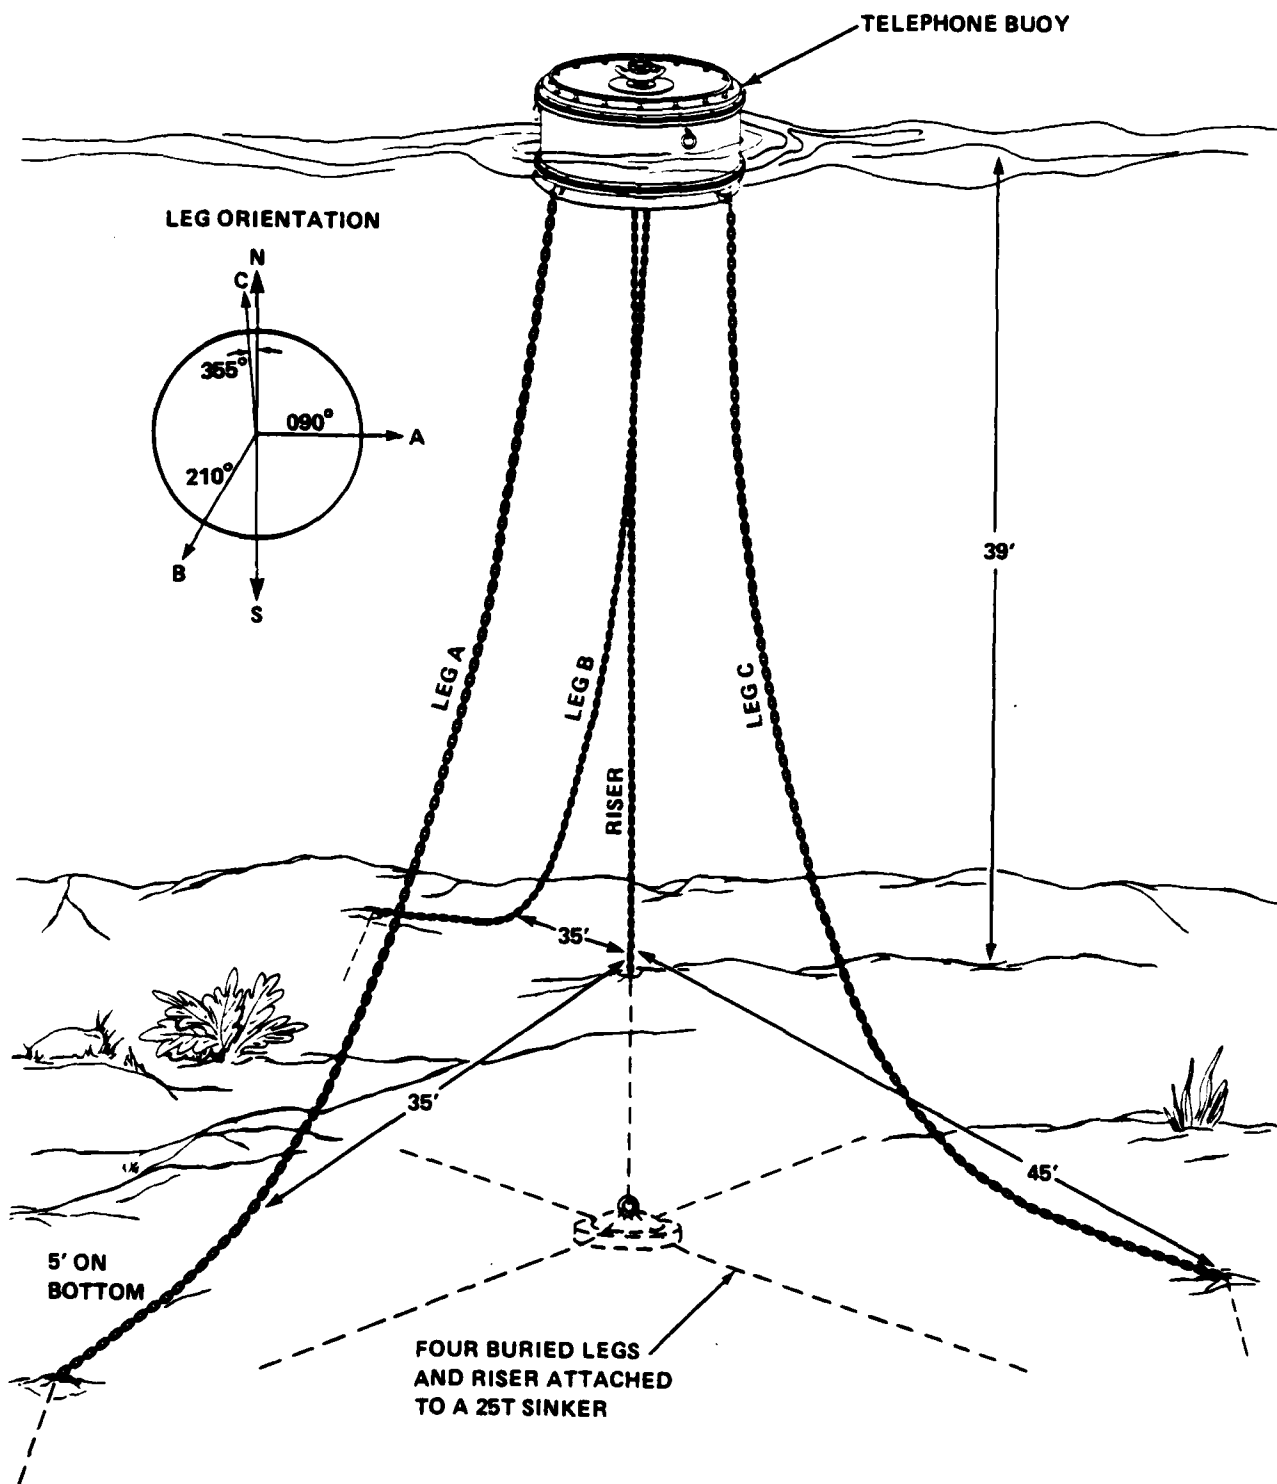
FIGURE A-1. SCHEMATIC DRAWING OF MOORING 1N

This is a 15-foot-diameter Japanese designed telephone-type buoy with a hawsepipe. The buoy has three legs attached to its padeyes and a riser chain. A 6-foot section of the fender has been sheared off, and the chafing rail is bent and broken. The 6-inch shackle atop the buoy was freshly painted.

The riser is oversized 4-inch chain. Double link measurements taken showed that the chain is worn to between 80 and 90 percent of its original wire diameter. The riser does not have a marine growth covering and enters the bottom at a water depth of 39 feet. The remainder of the riser, the 25-ton sinker, ground legs, and anchors were not visible for inspection.

The three ground legs attached to the buoy padeyes were inspected. Each consisted originally of 3-inch chain. Although most double link measurements were greater than 80 percent, one measurement of leg B, the south-southwest leg, was only 79 percent of its original wire diameter. The legs are covered with a medium covering of marine growth, and each of the legs has scattered areas of extreme rust.

This mooring is in fair condition.

A measurement of less than 80 percent of any mooring component is normally cause for a mooring to be removed from service until an overhaul can be performed. However, in the case of this mooring, the oversized (4-inch) riser is more than capable of handling class A design loads. The worn section of the ground leg does not pose a threat to the safety of the mooring.

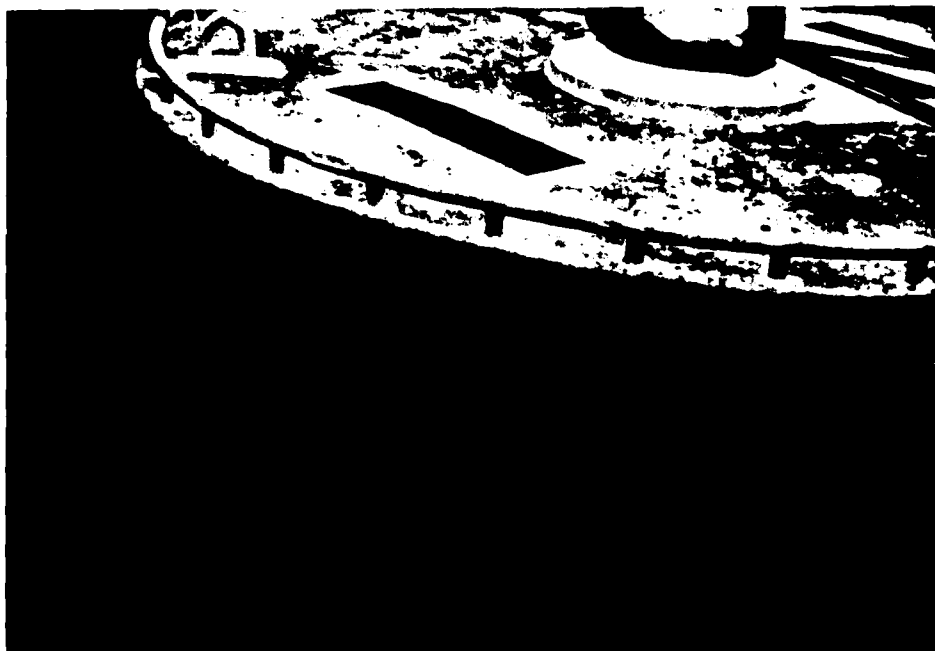
**Section of Lower Fender Sheared off Buoy I-N**

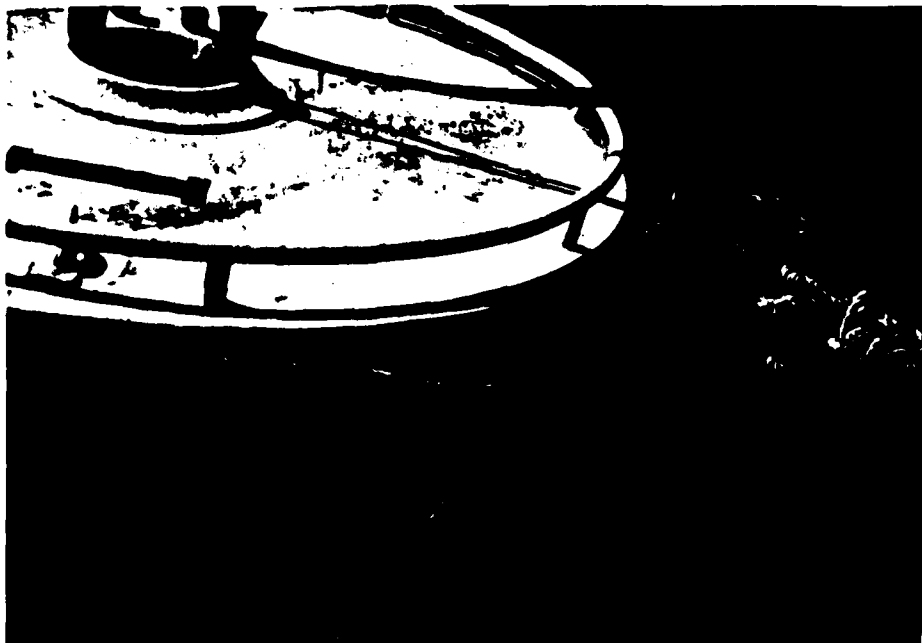
**Damaged Fender of Buoy I-2**

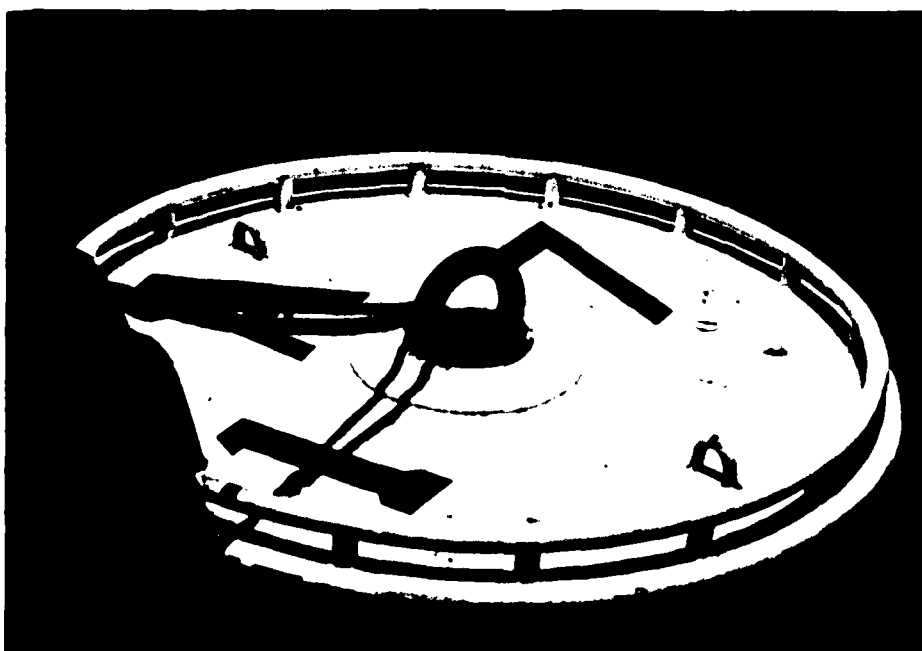
**Buoy A-17. Excellent Topside Condition**

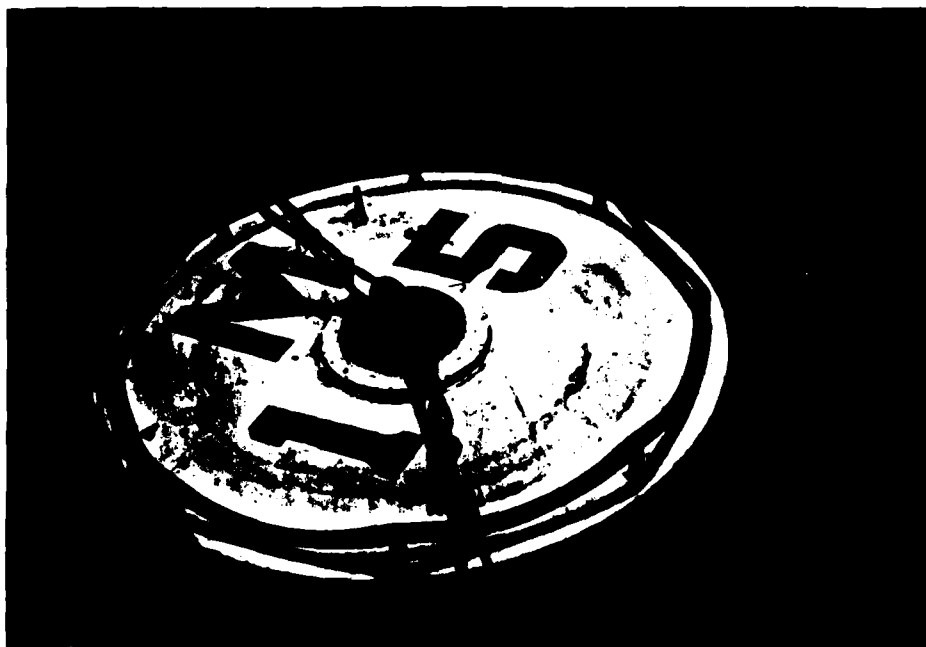
**Buoy M-15 with Damaged Chafing Rail**
